Photo Report of Koteles Garage

Site Inspection Date: 06/10/2020

Inspector: Nathan Marcus, E.I.T.

Prepared for: Levandosky v. Koteles Dispute

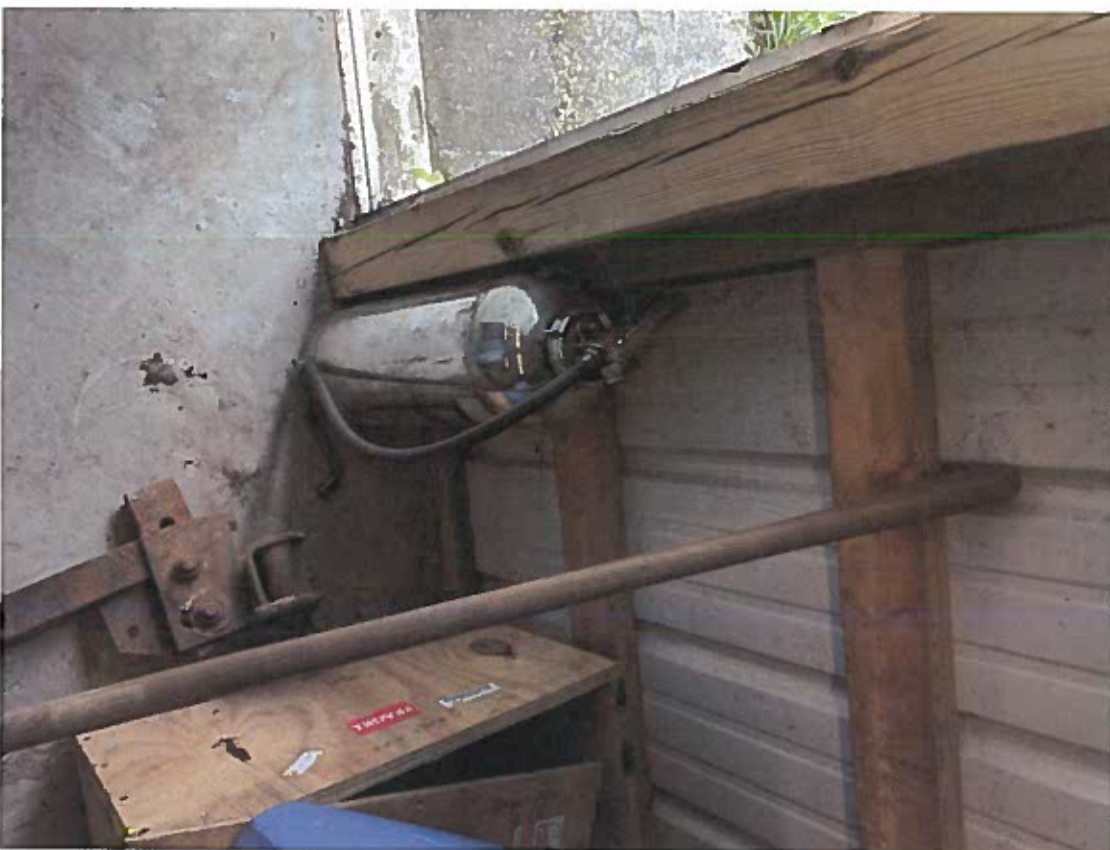
Old partially charged fire extinguisher. Only fire suppression found in rear white building. Where burn mark was found in ground outside adjacent to the structure.

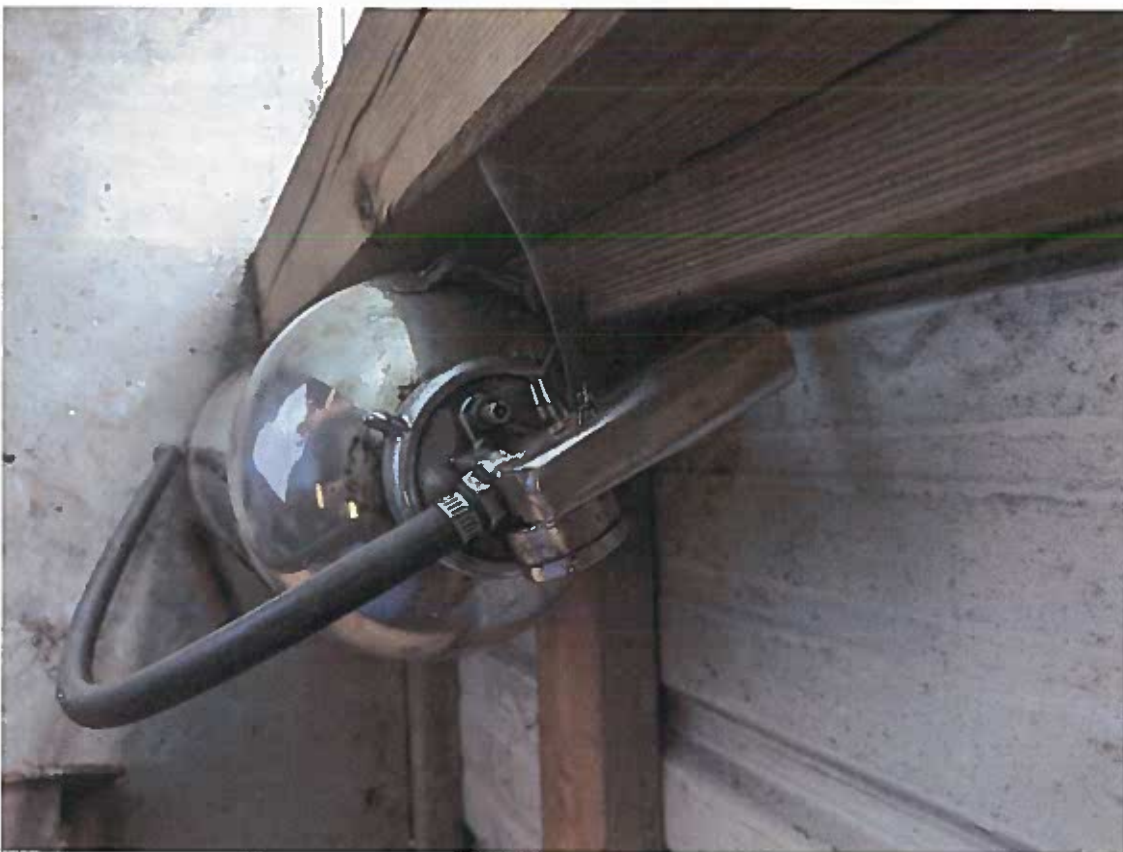
Old partially charged fire extinguisher. Only fire suppression found in rear white building. Where burn mark was found in ground outside adjacent to the structure.

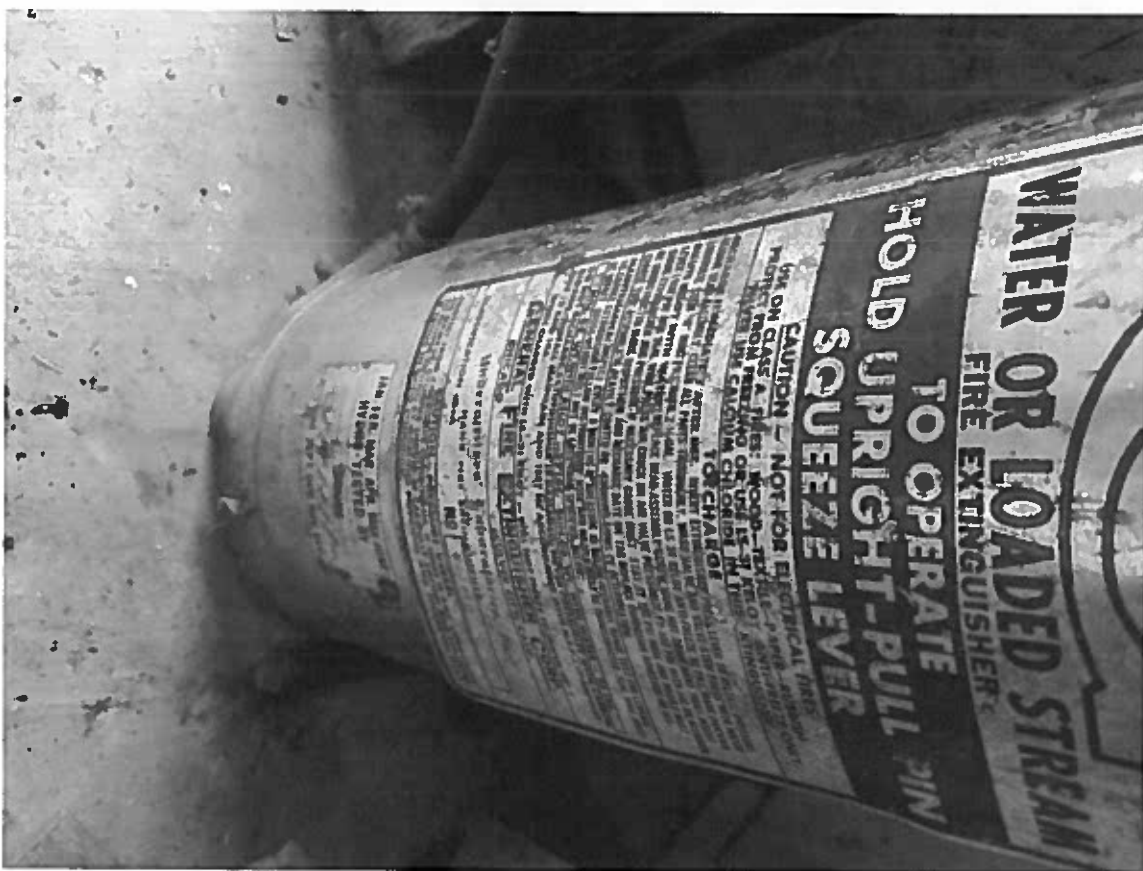
Old partially charged fire extinguisher. Only fire suppression found in rear building.

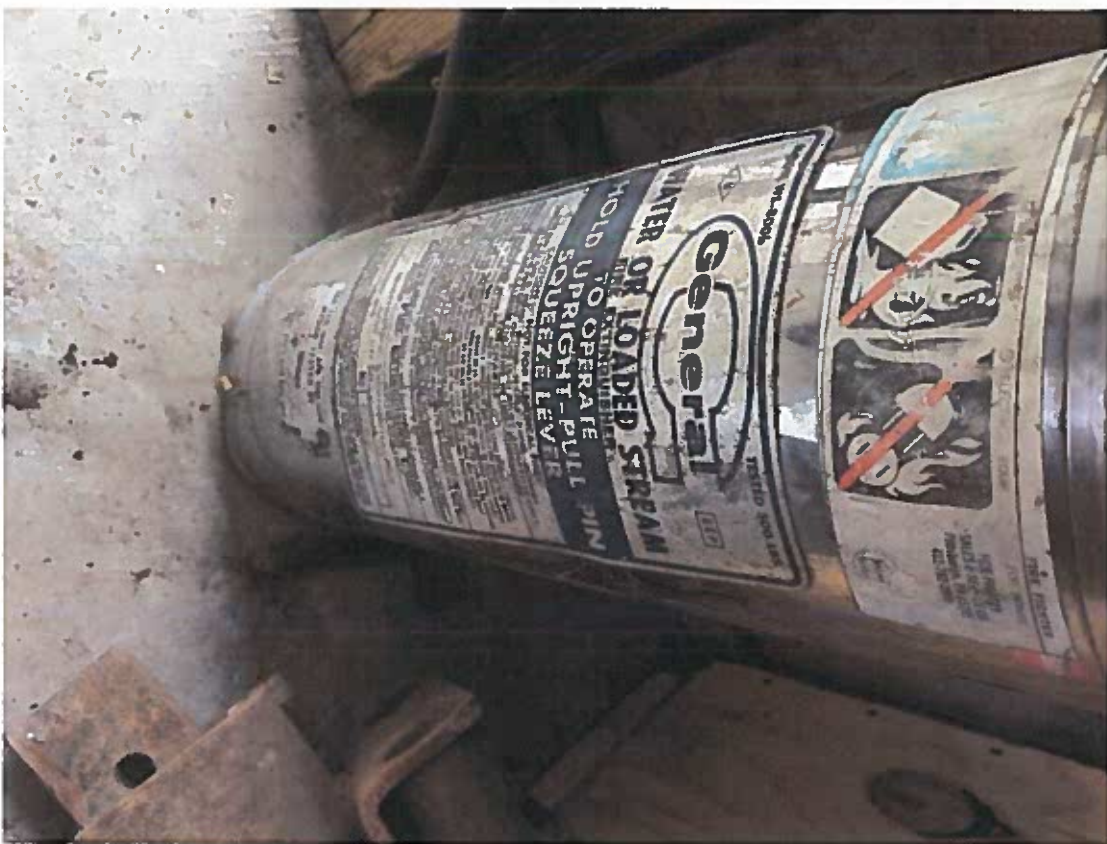
Old partially charged fire extinguisher. Only fire suppression found in rear building.

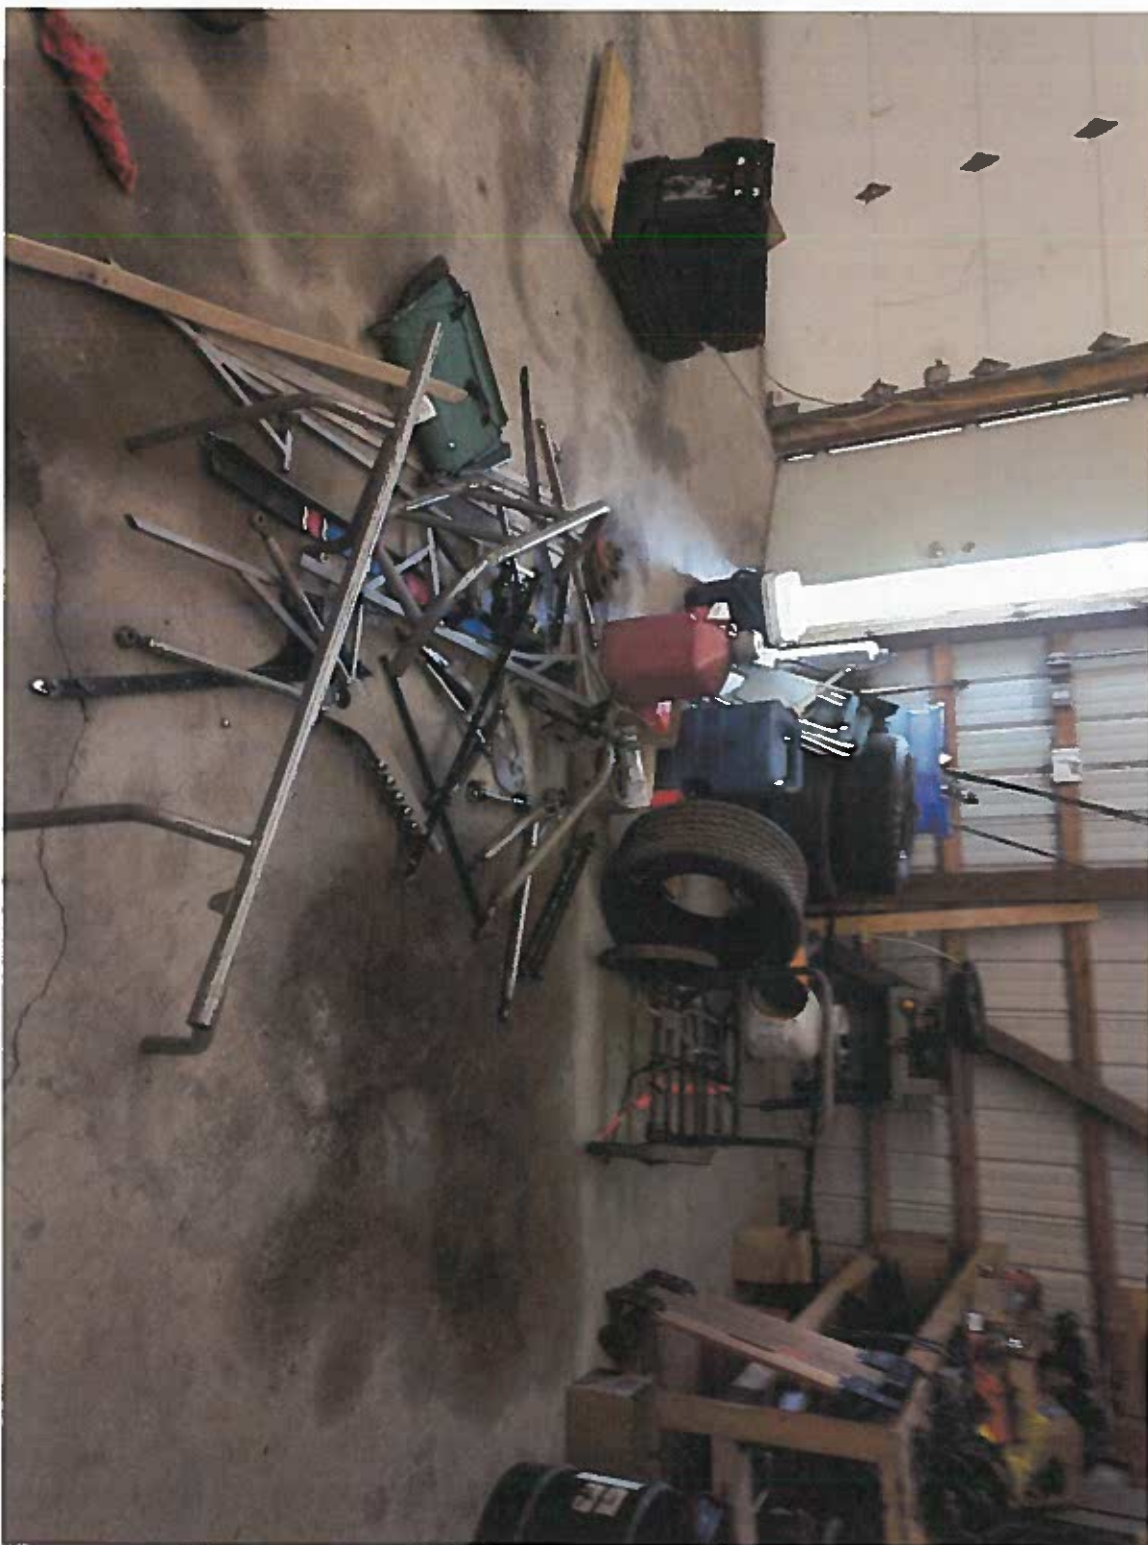
Oil stain and floor cracking in rear white building.

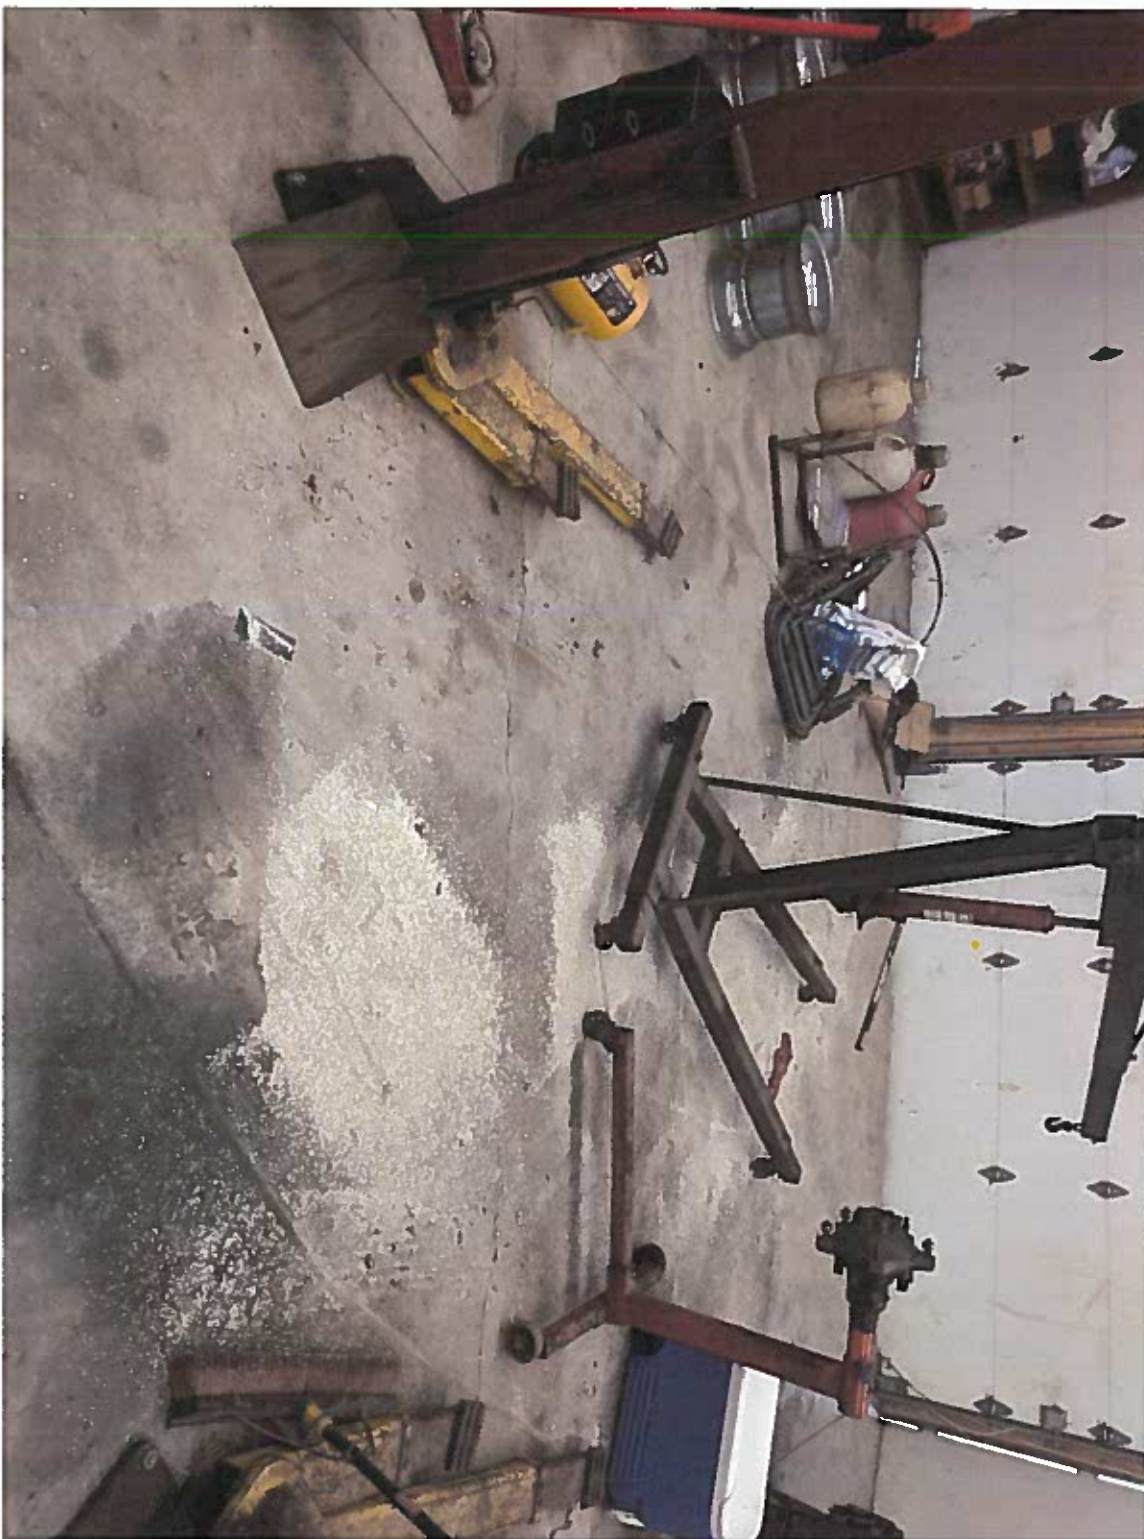
Oil spill absorbing material left on the floor in the rear white building.

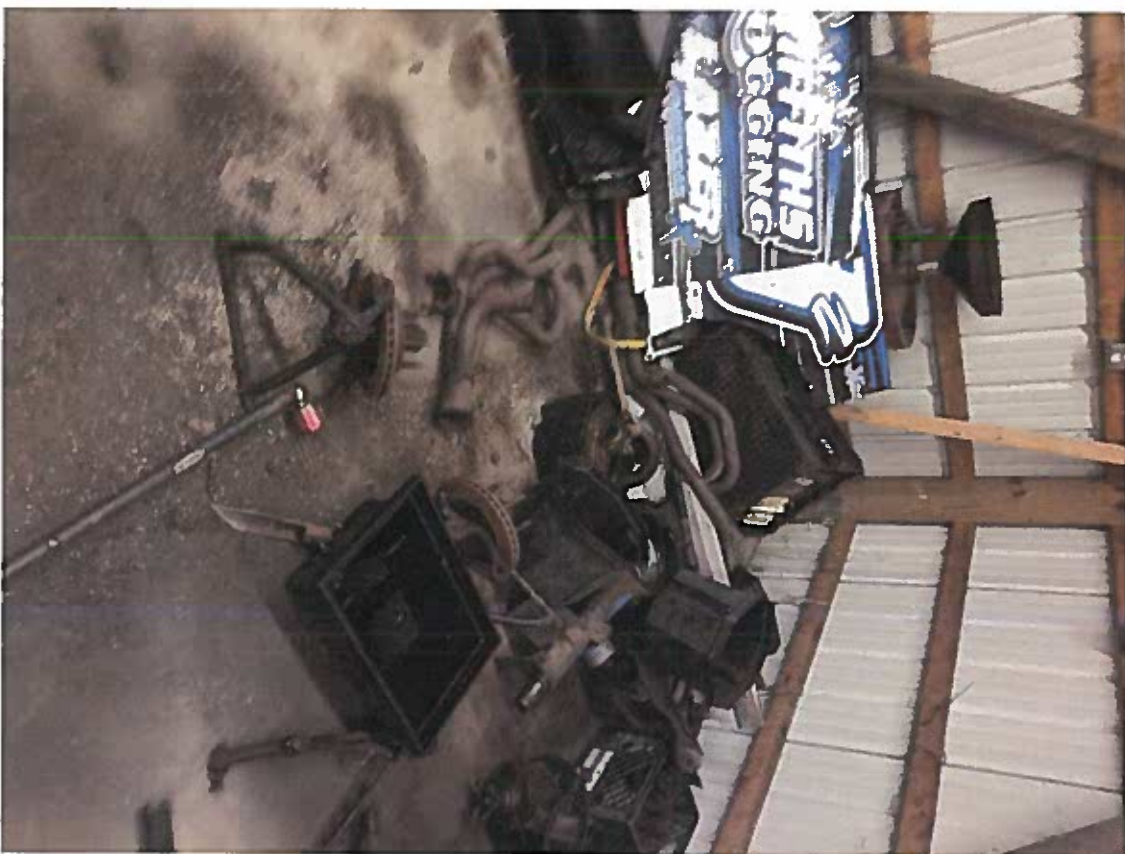
Open oil containers and oil spill absorbant material left on the floor.

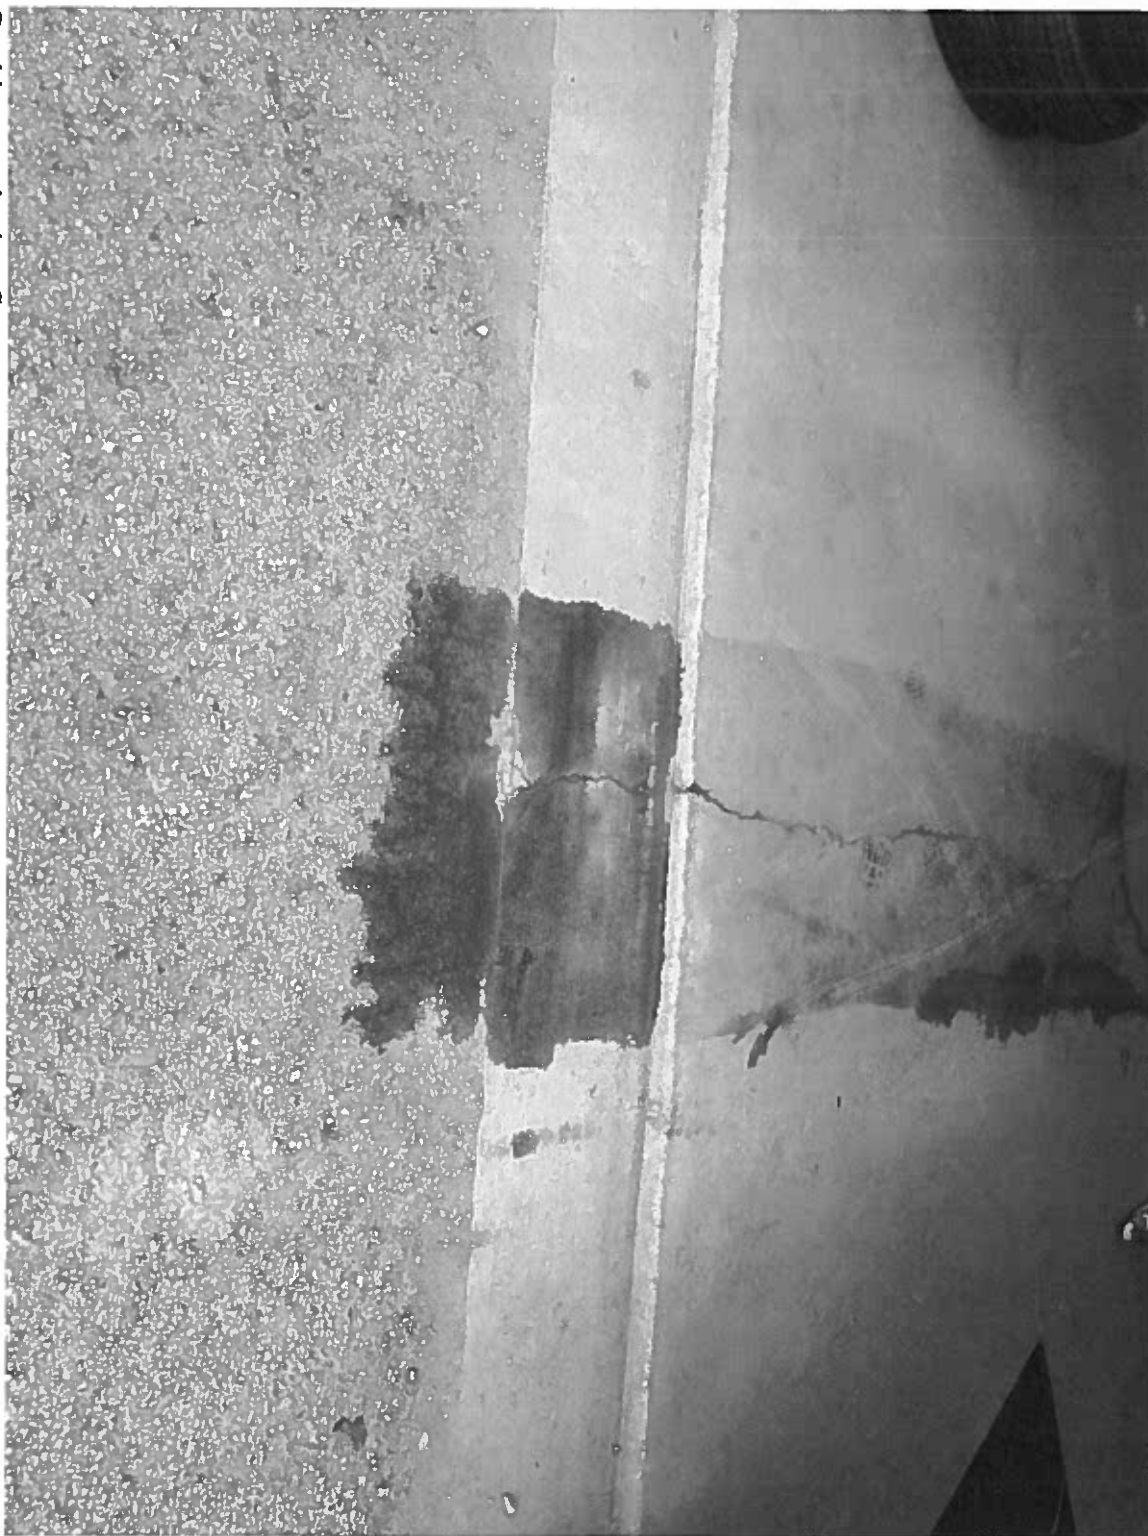
Cracking seen in shop floor area.

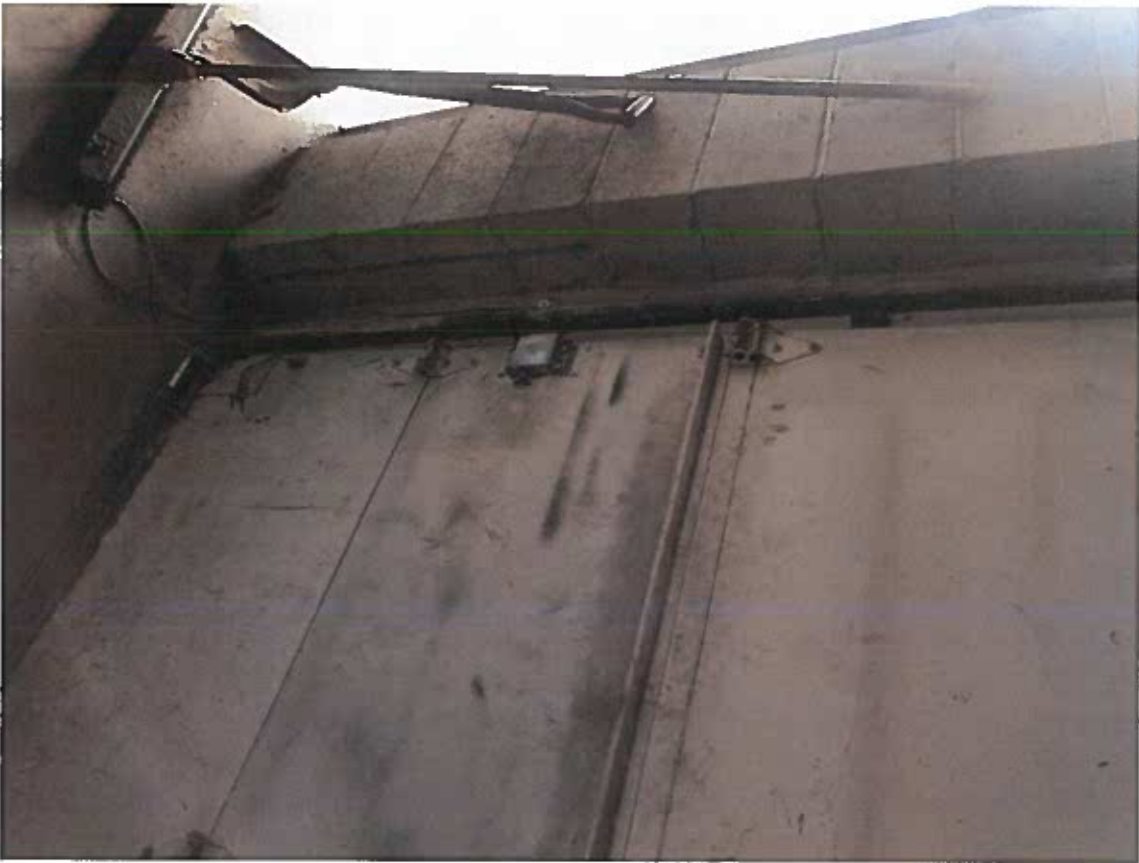
Moderate damage to this main bay garage door.

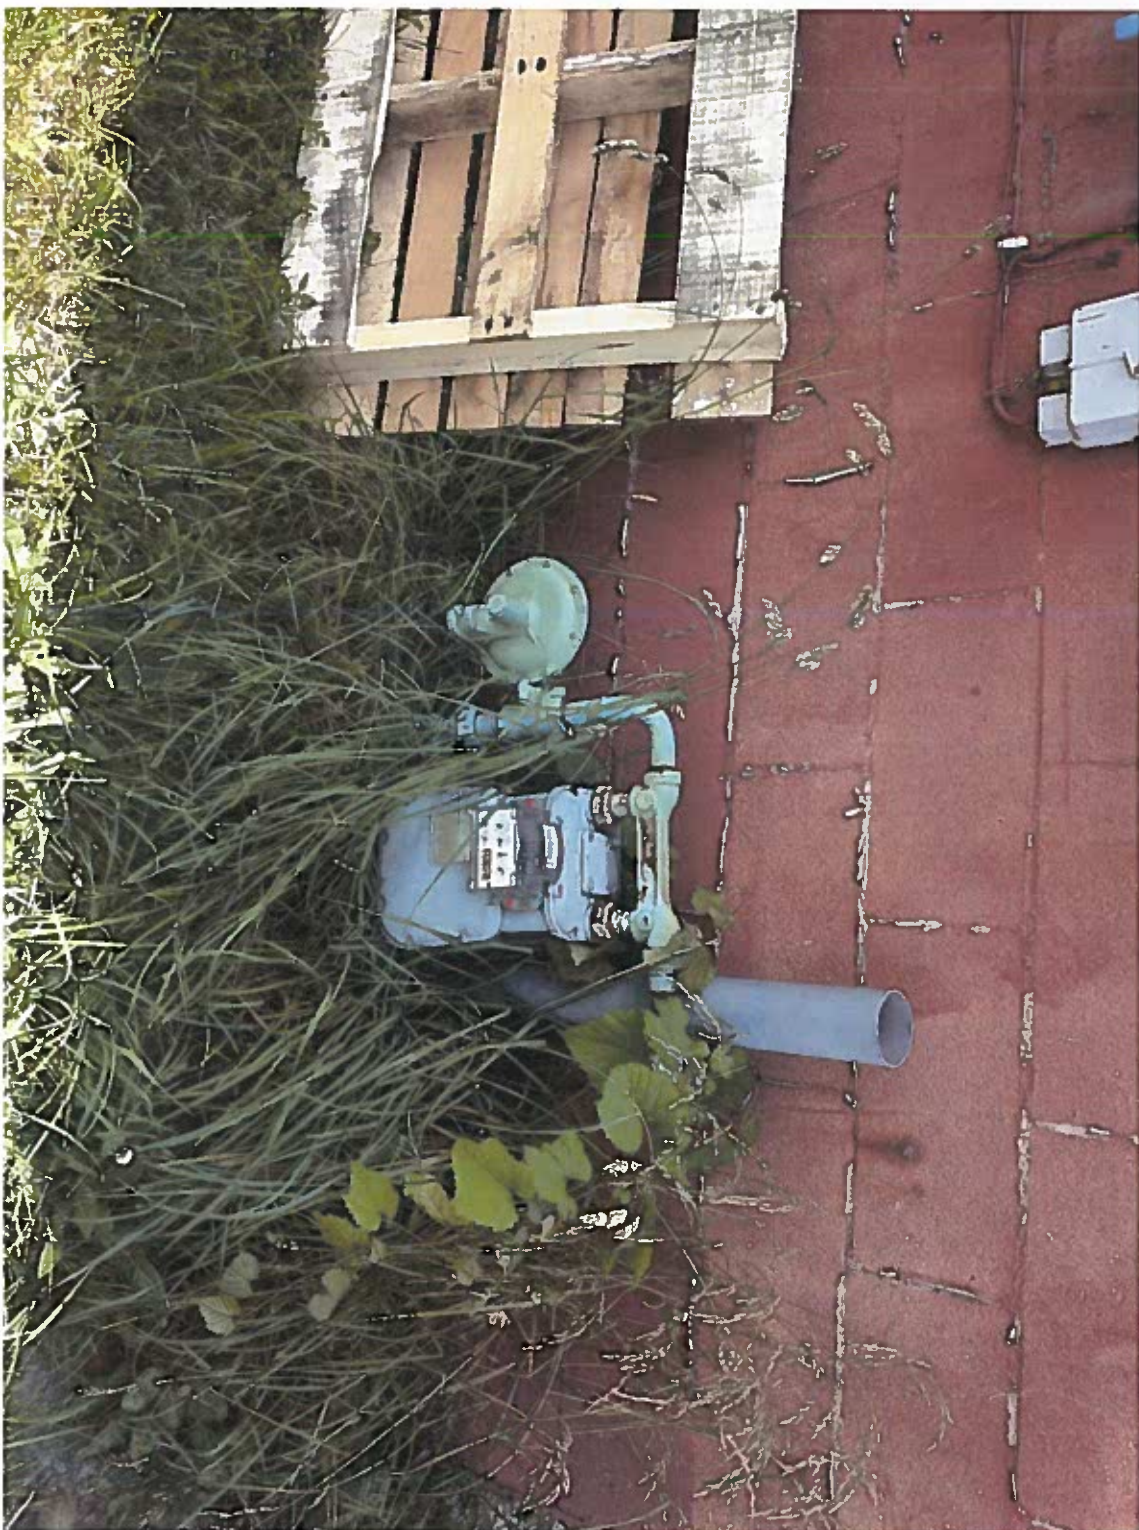
Overgrowth and loose pallet near the property's utility connections.

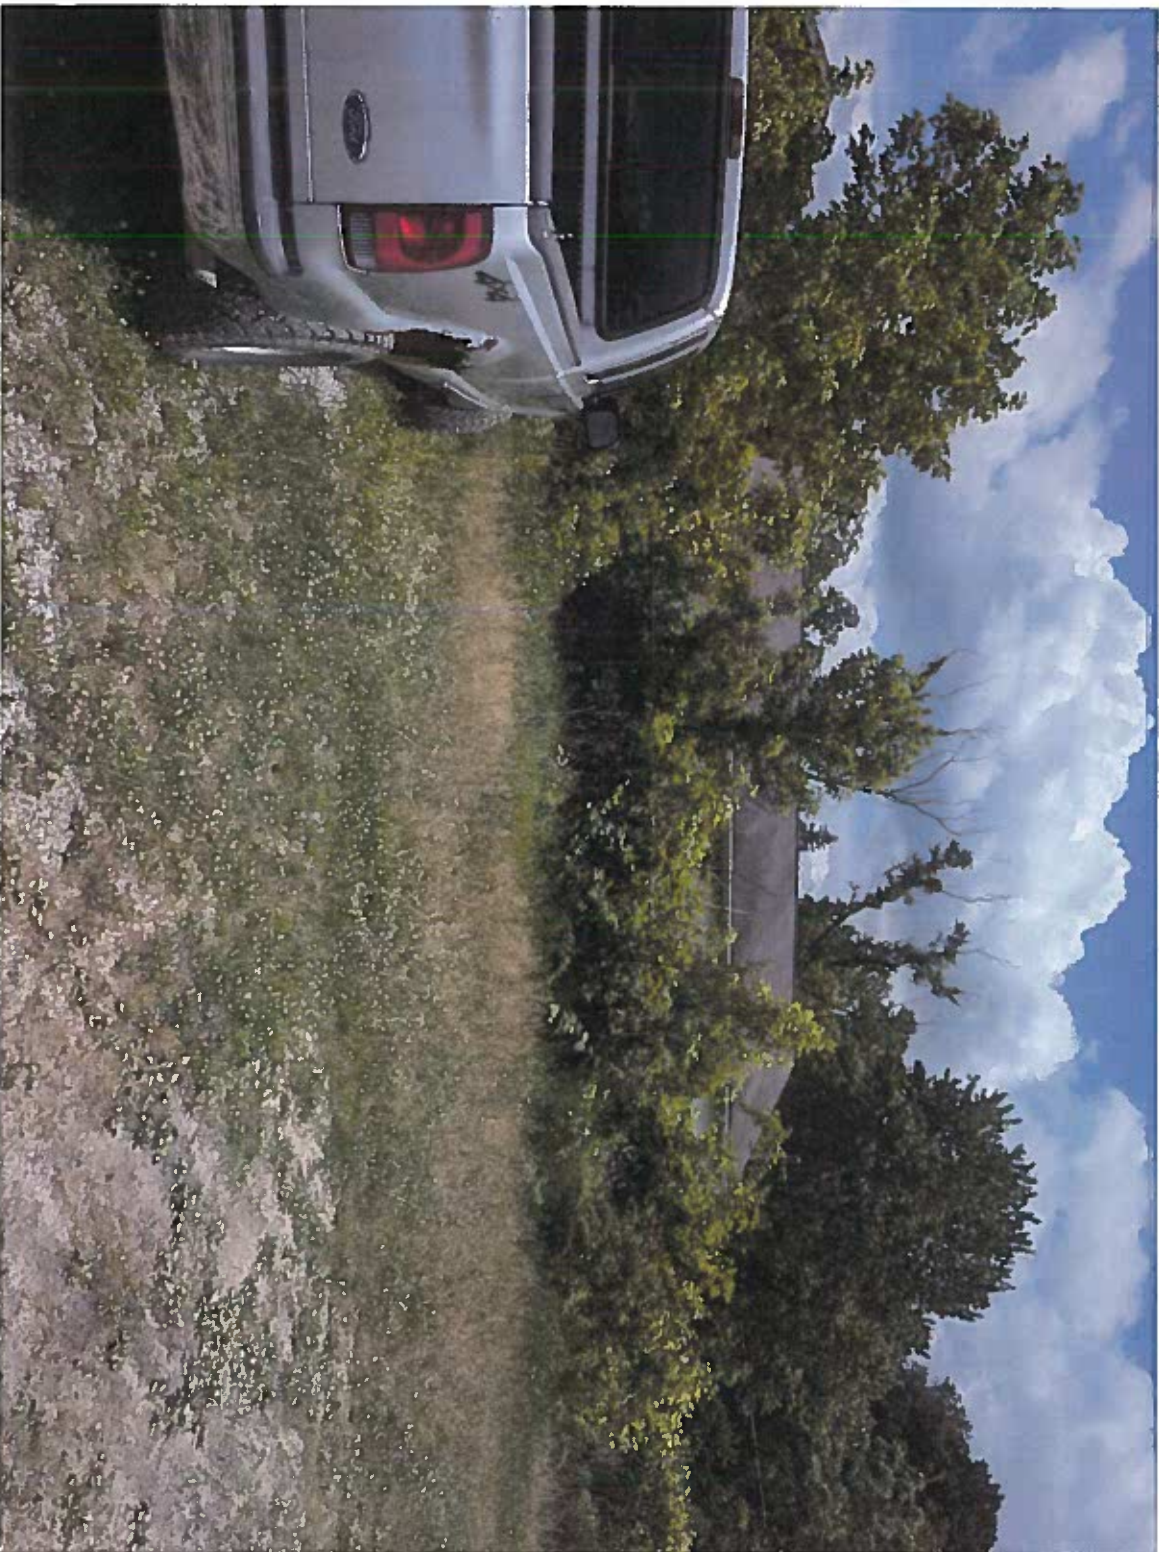
Overgrowth and weeds on the rear lot.

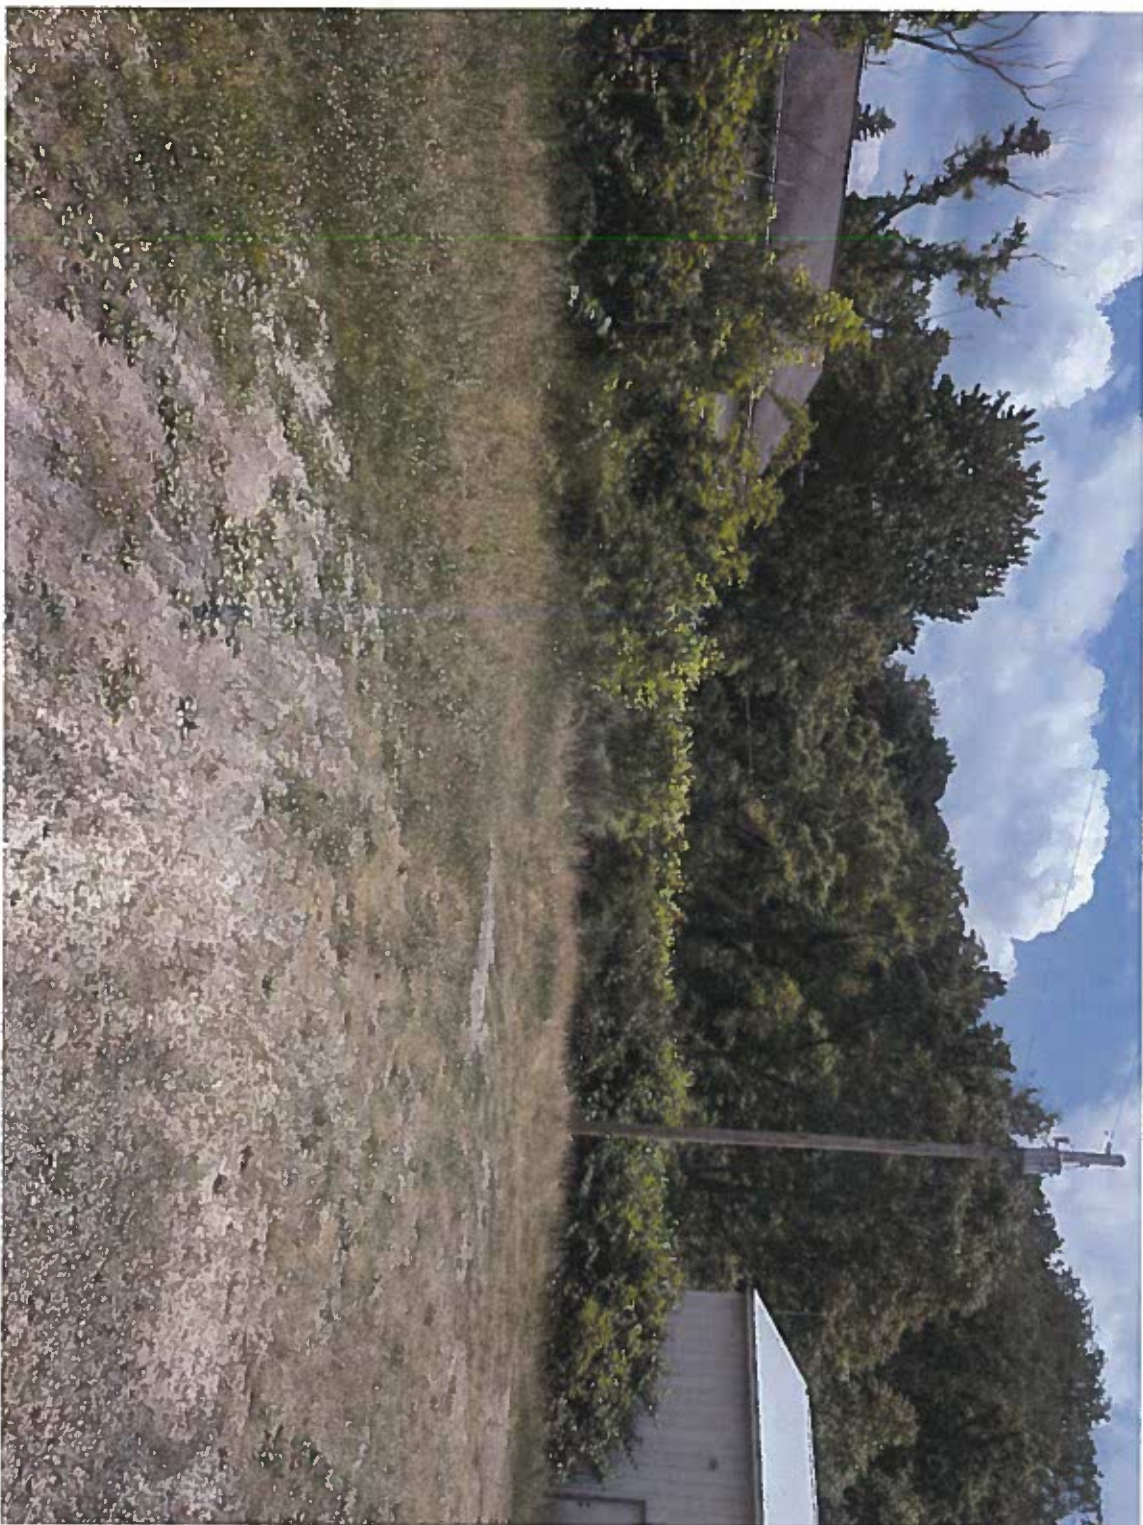
Overgrowth and weeds on the rear lot.

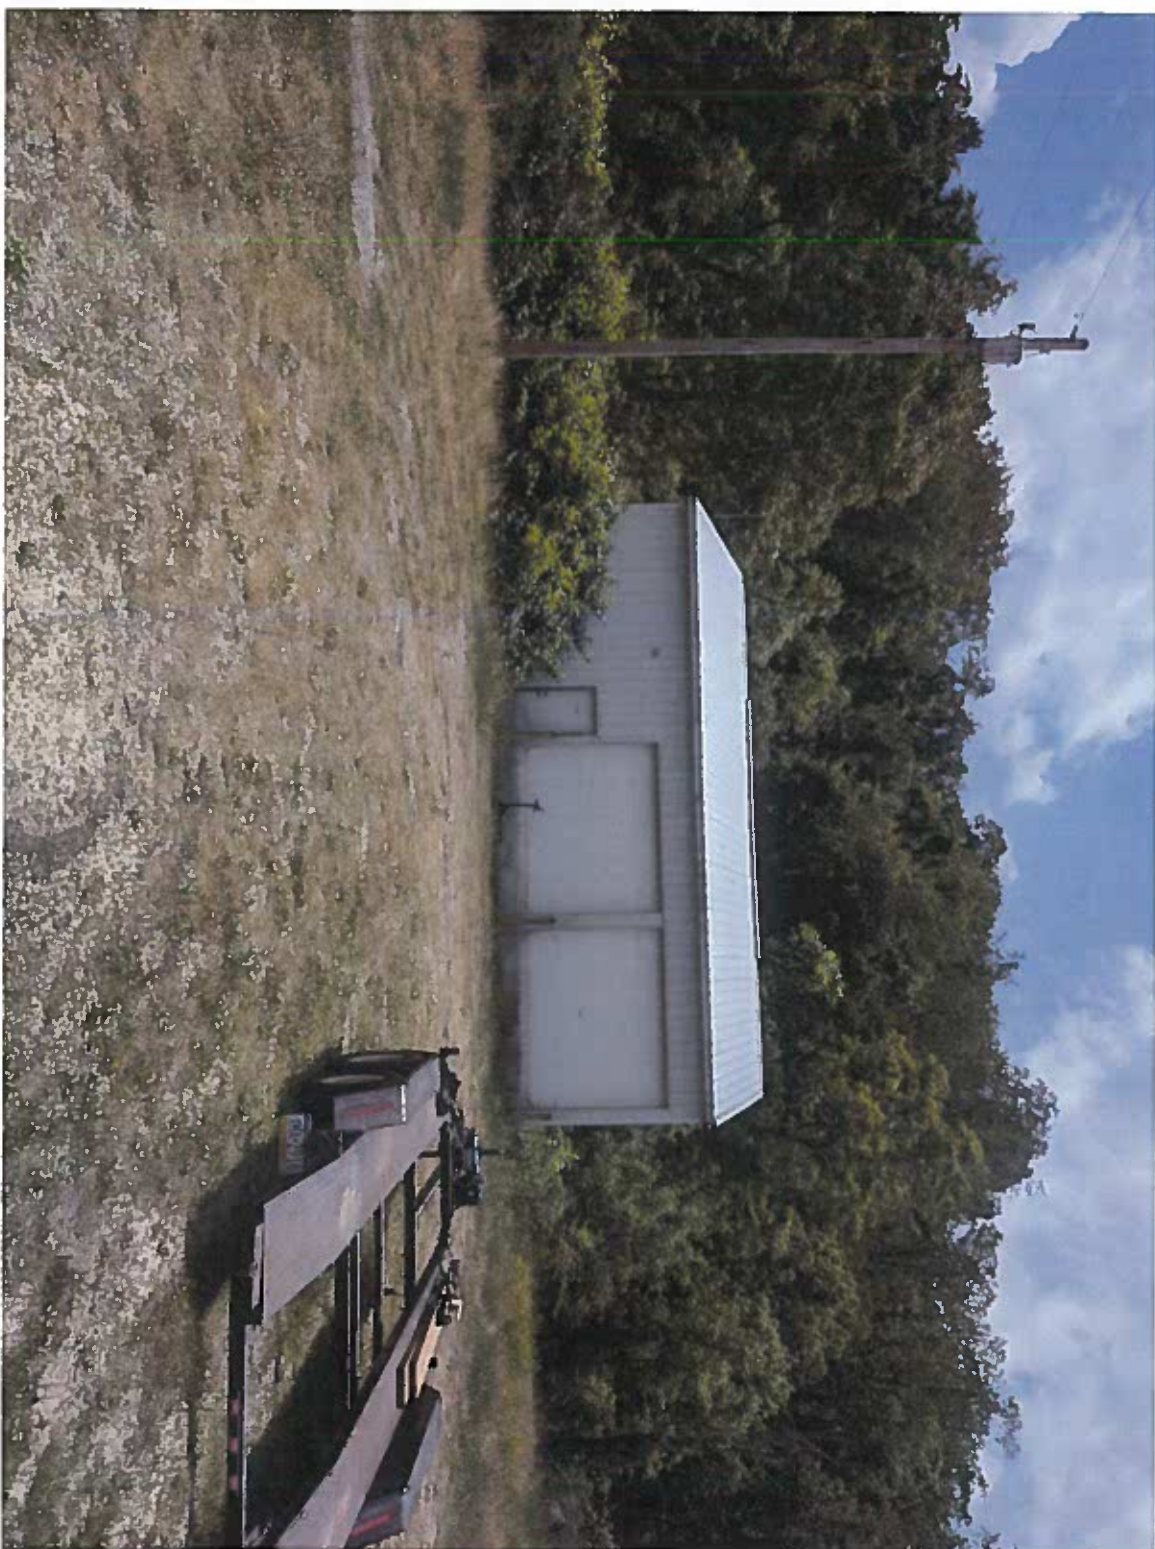
Overgrowth and weeds on the rear lot.

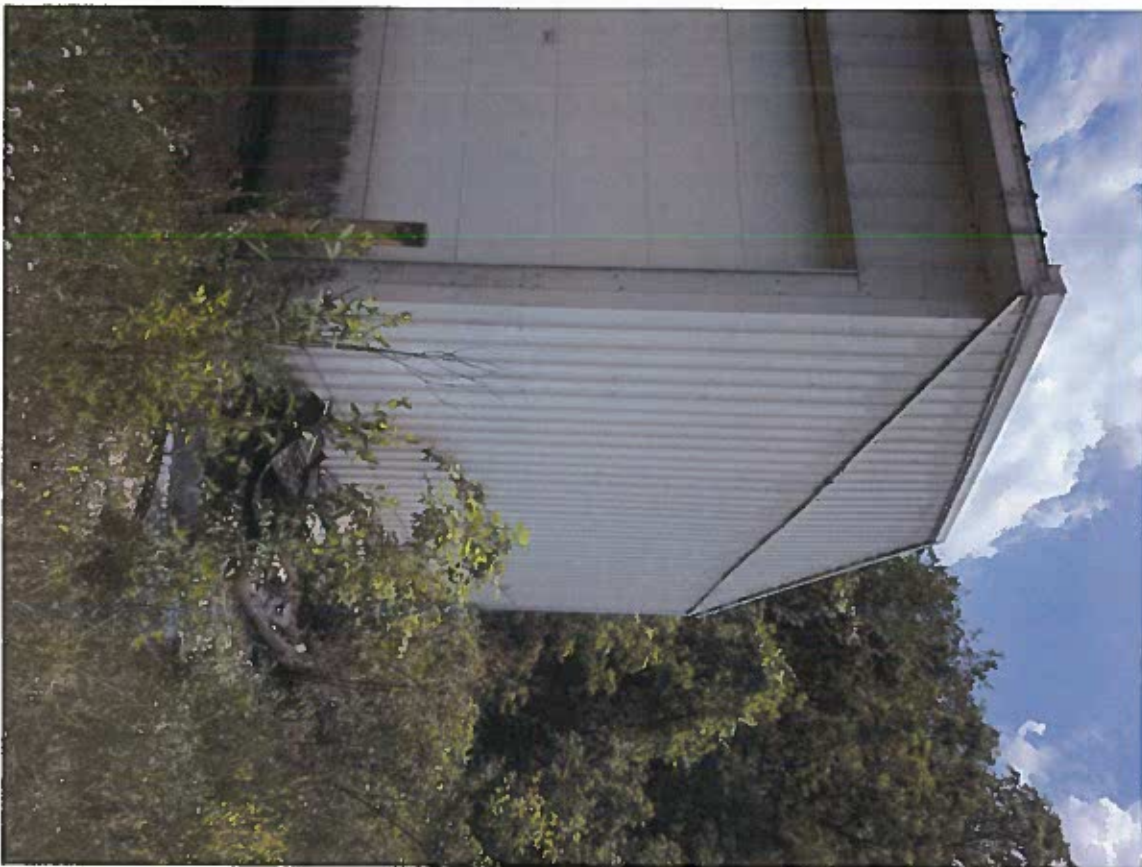
Overgrowth and weeds on the rear lot.

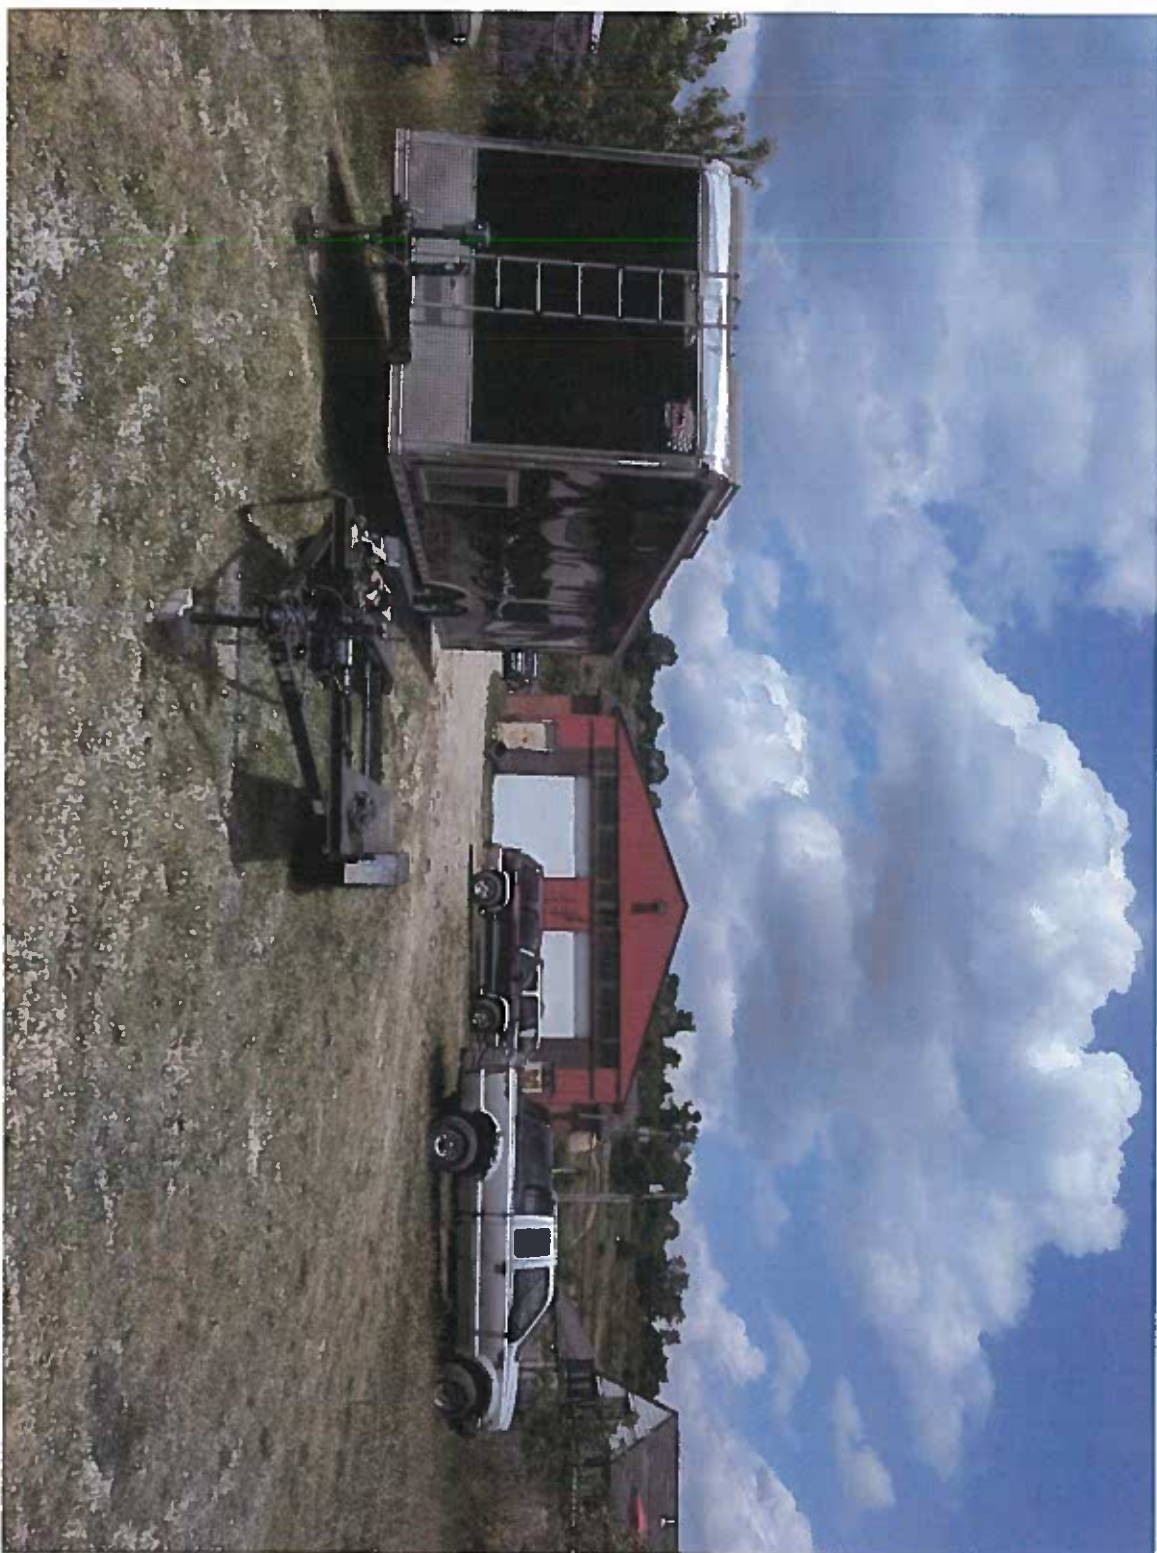
Overgrowth and weeds on the rear lot.

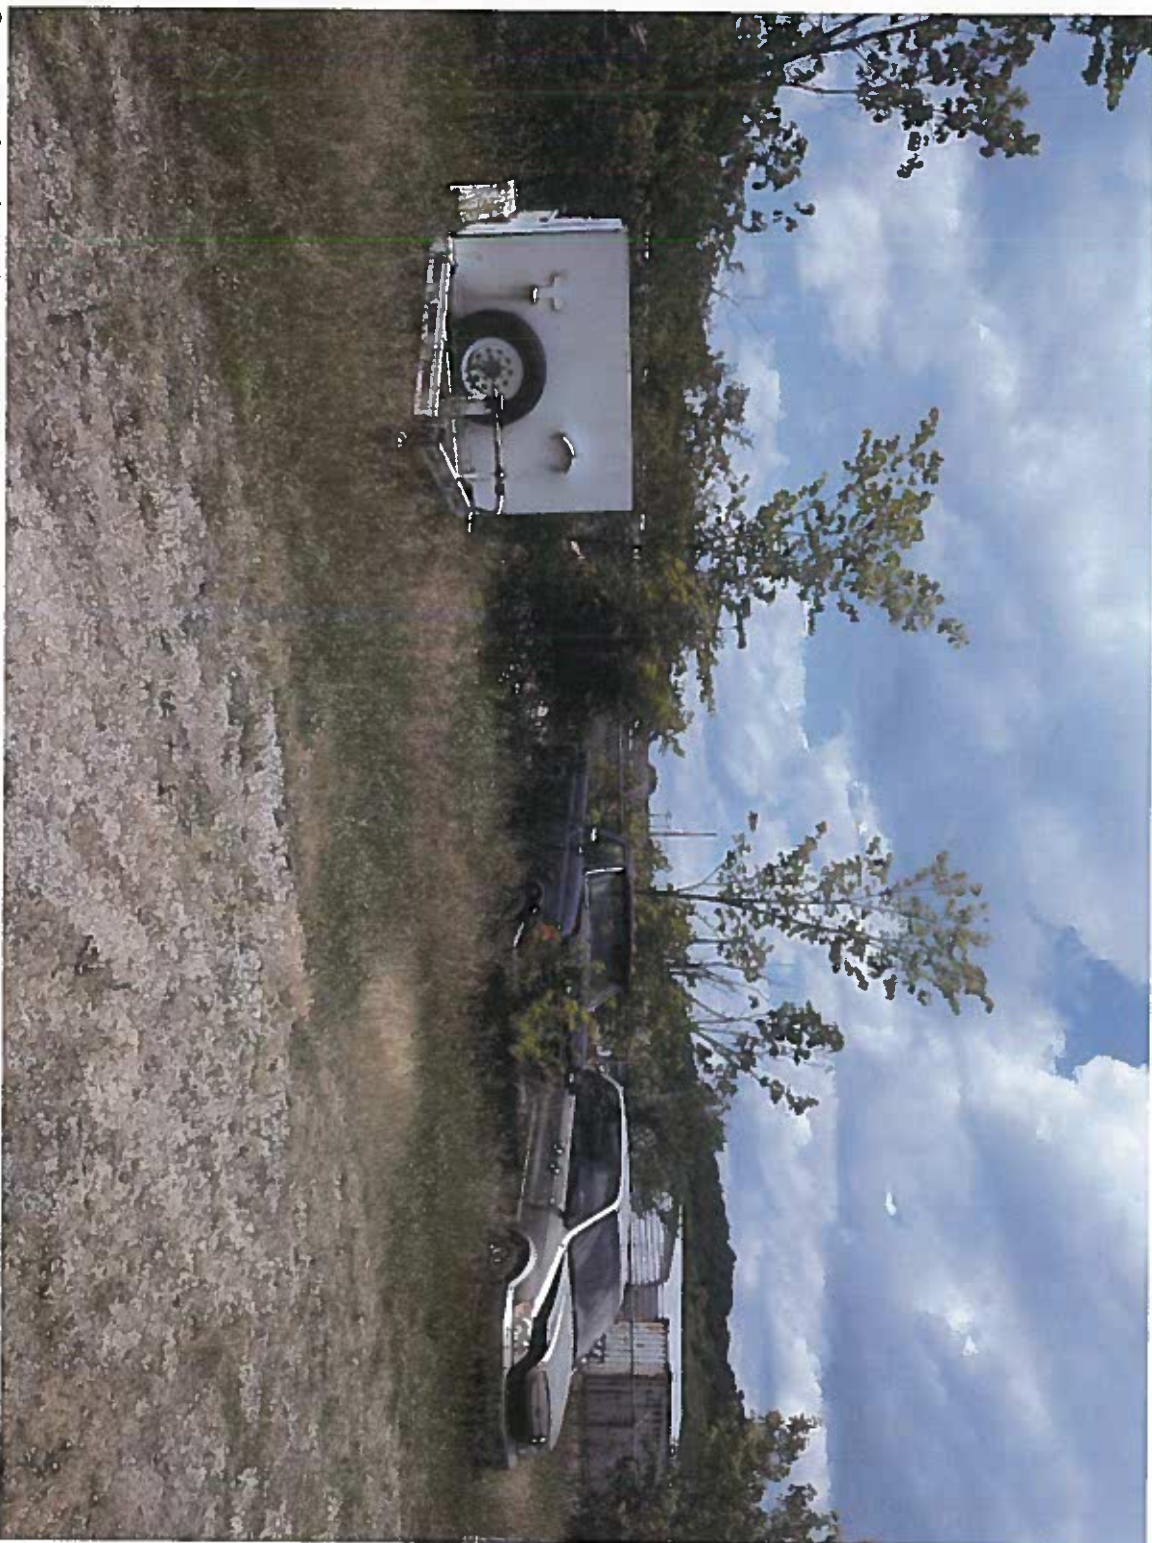
Overgrowth and weeds on the rear lot.
